# **Expedient Shelter Construction and Occupancy Experiments**

Cresson H. Kearny

**OAK RIDGE NATIONAL LABORATORY**

MARCH 1976

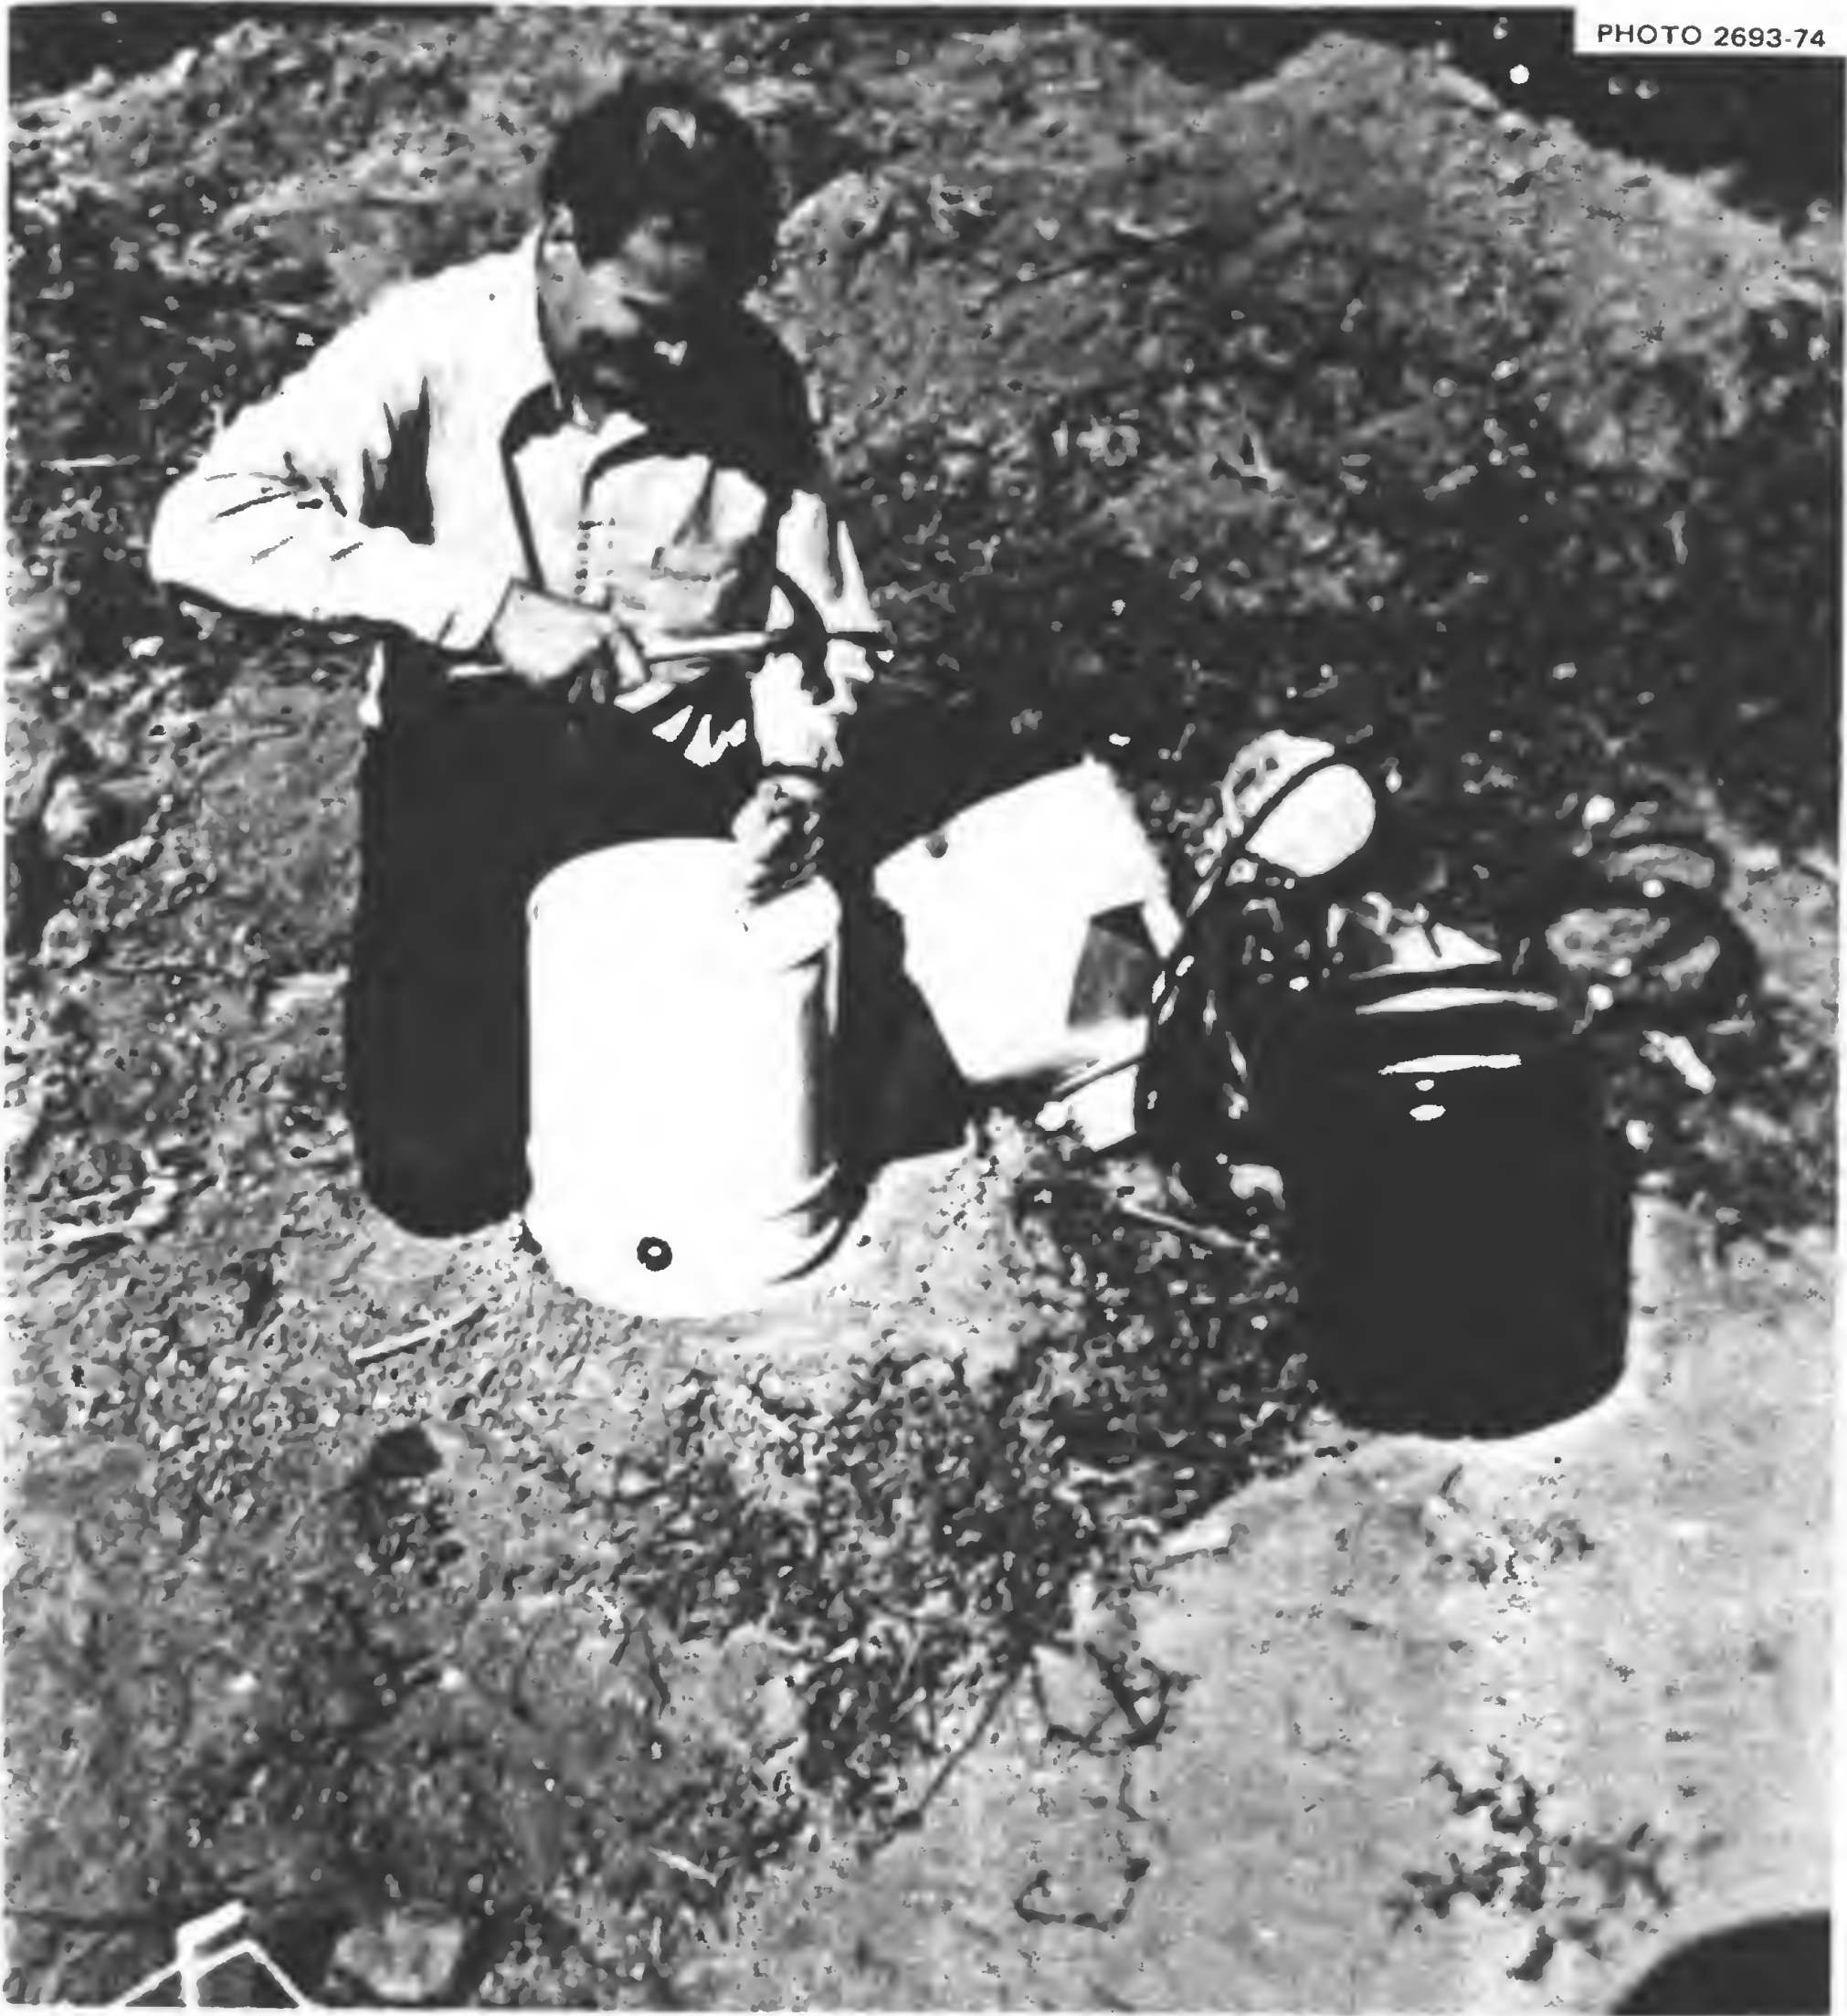
**Fig. 4.25.** The father starting work, with cold chisel and hammer, on his clever design of an odorless expedient toilet. In order to determine how long it would take to build and install this toilet under field conditions, he brought from his home the two 5-gallon cans, a 5-gallon plastic water jug (shown upside down), a garden hose, a complete toilet seat, an uncut piece of plywood, a tube, some cord, and freezer tape – all the materials needed to build this toilet.

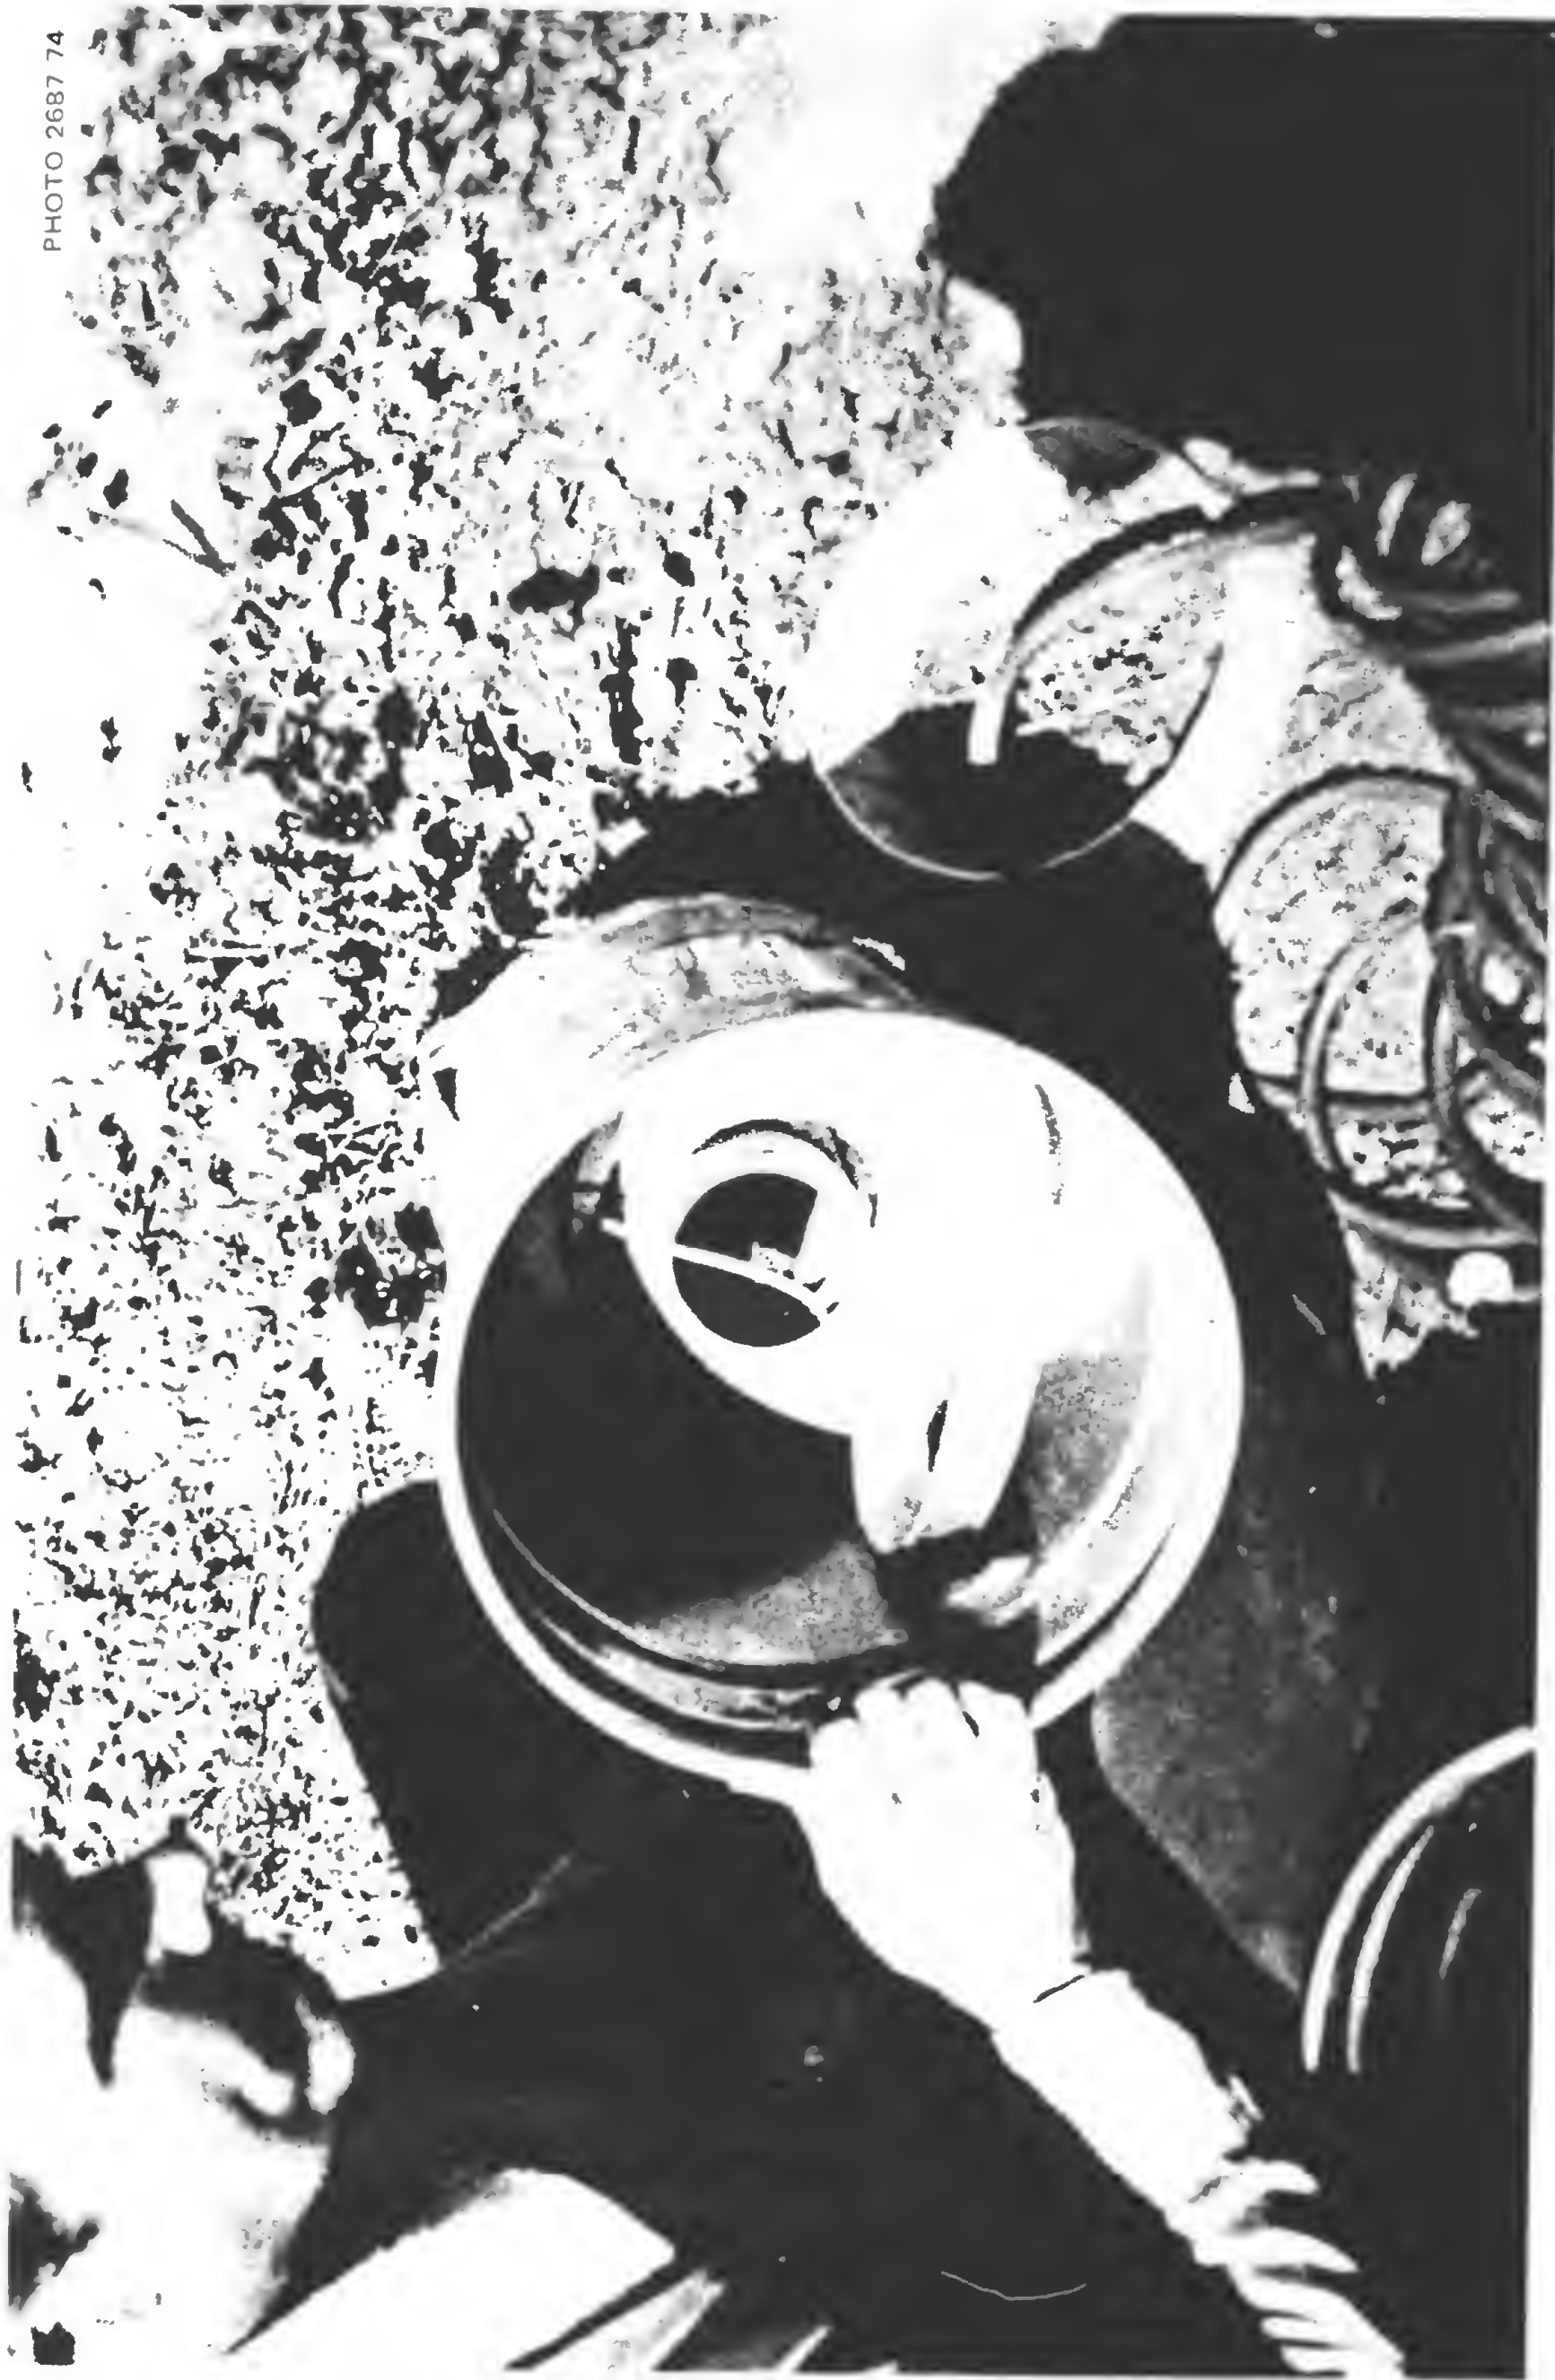
Fig. 4.27. View looking into what was to become the uppermost 5-gallon can of the 10-gallon vented space. The toilet bowl is on the ground, below this can and attached to it. The mouth of the shortened, plastic water-jug bowl is shown extending through the hole cut into the bottom of this can. Freezer tape had been used to seal the cracks between these parts.

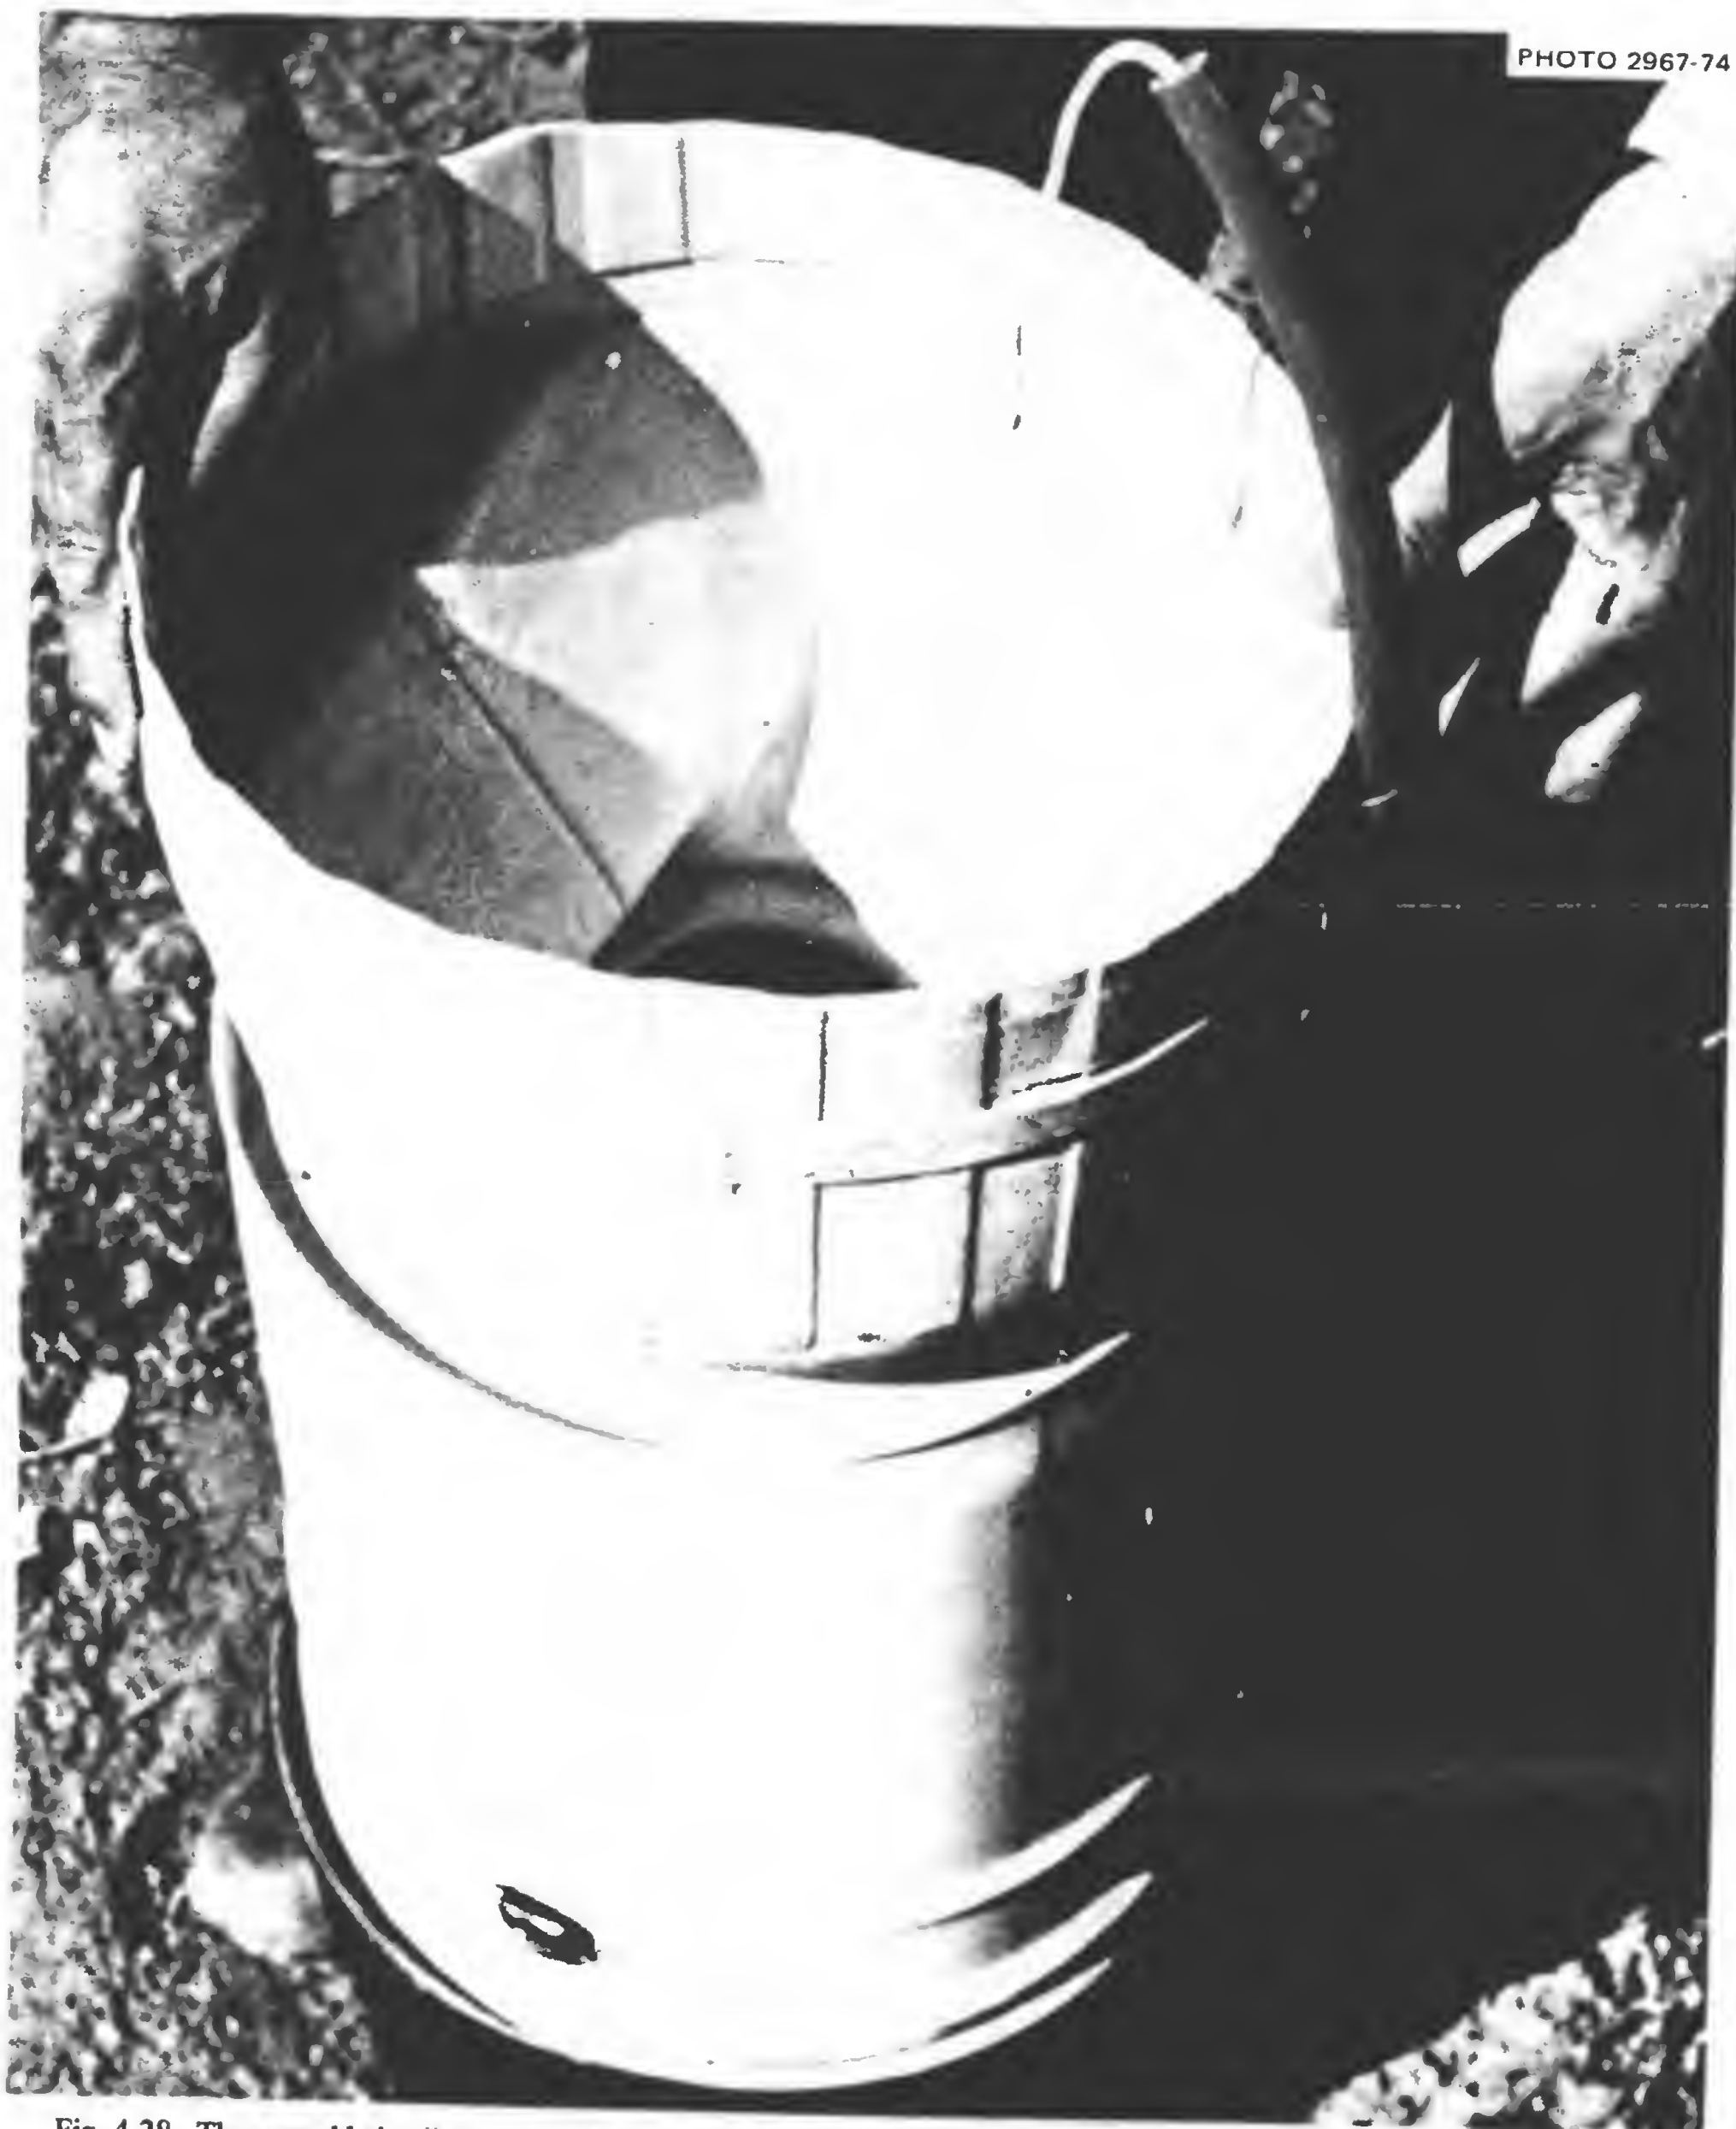
**Fig. 4.28.** The assembled toilet, except for its vent hose, the toilet seat, and the plywood base of the toilet seat. The pull cord (that operated the hinged water-sealable cake-pan valve) is shown extending out of the small rubber tube, which kept the pull cord out of contact with the earth.

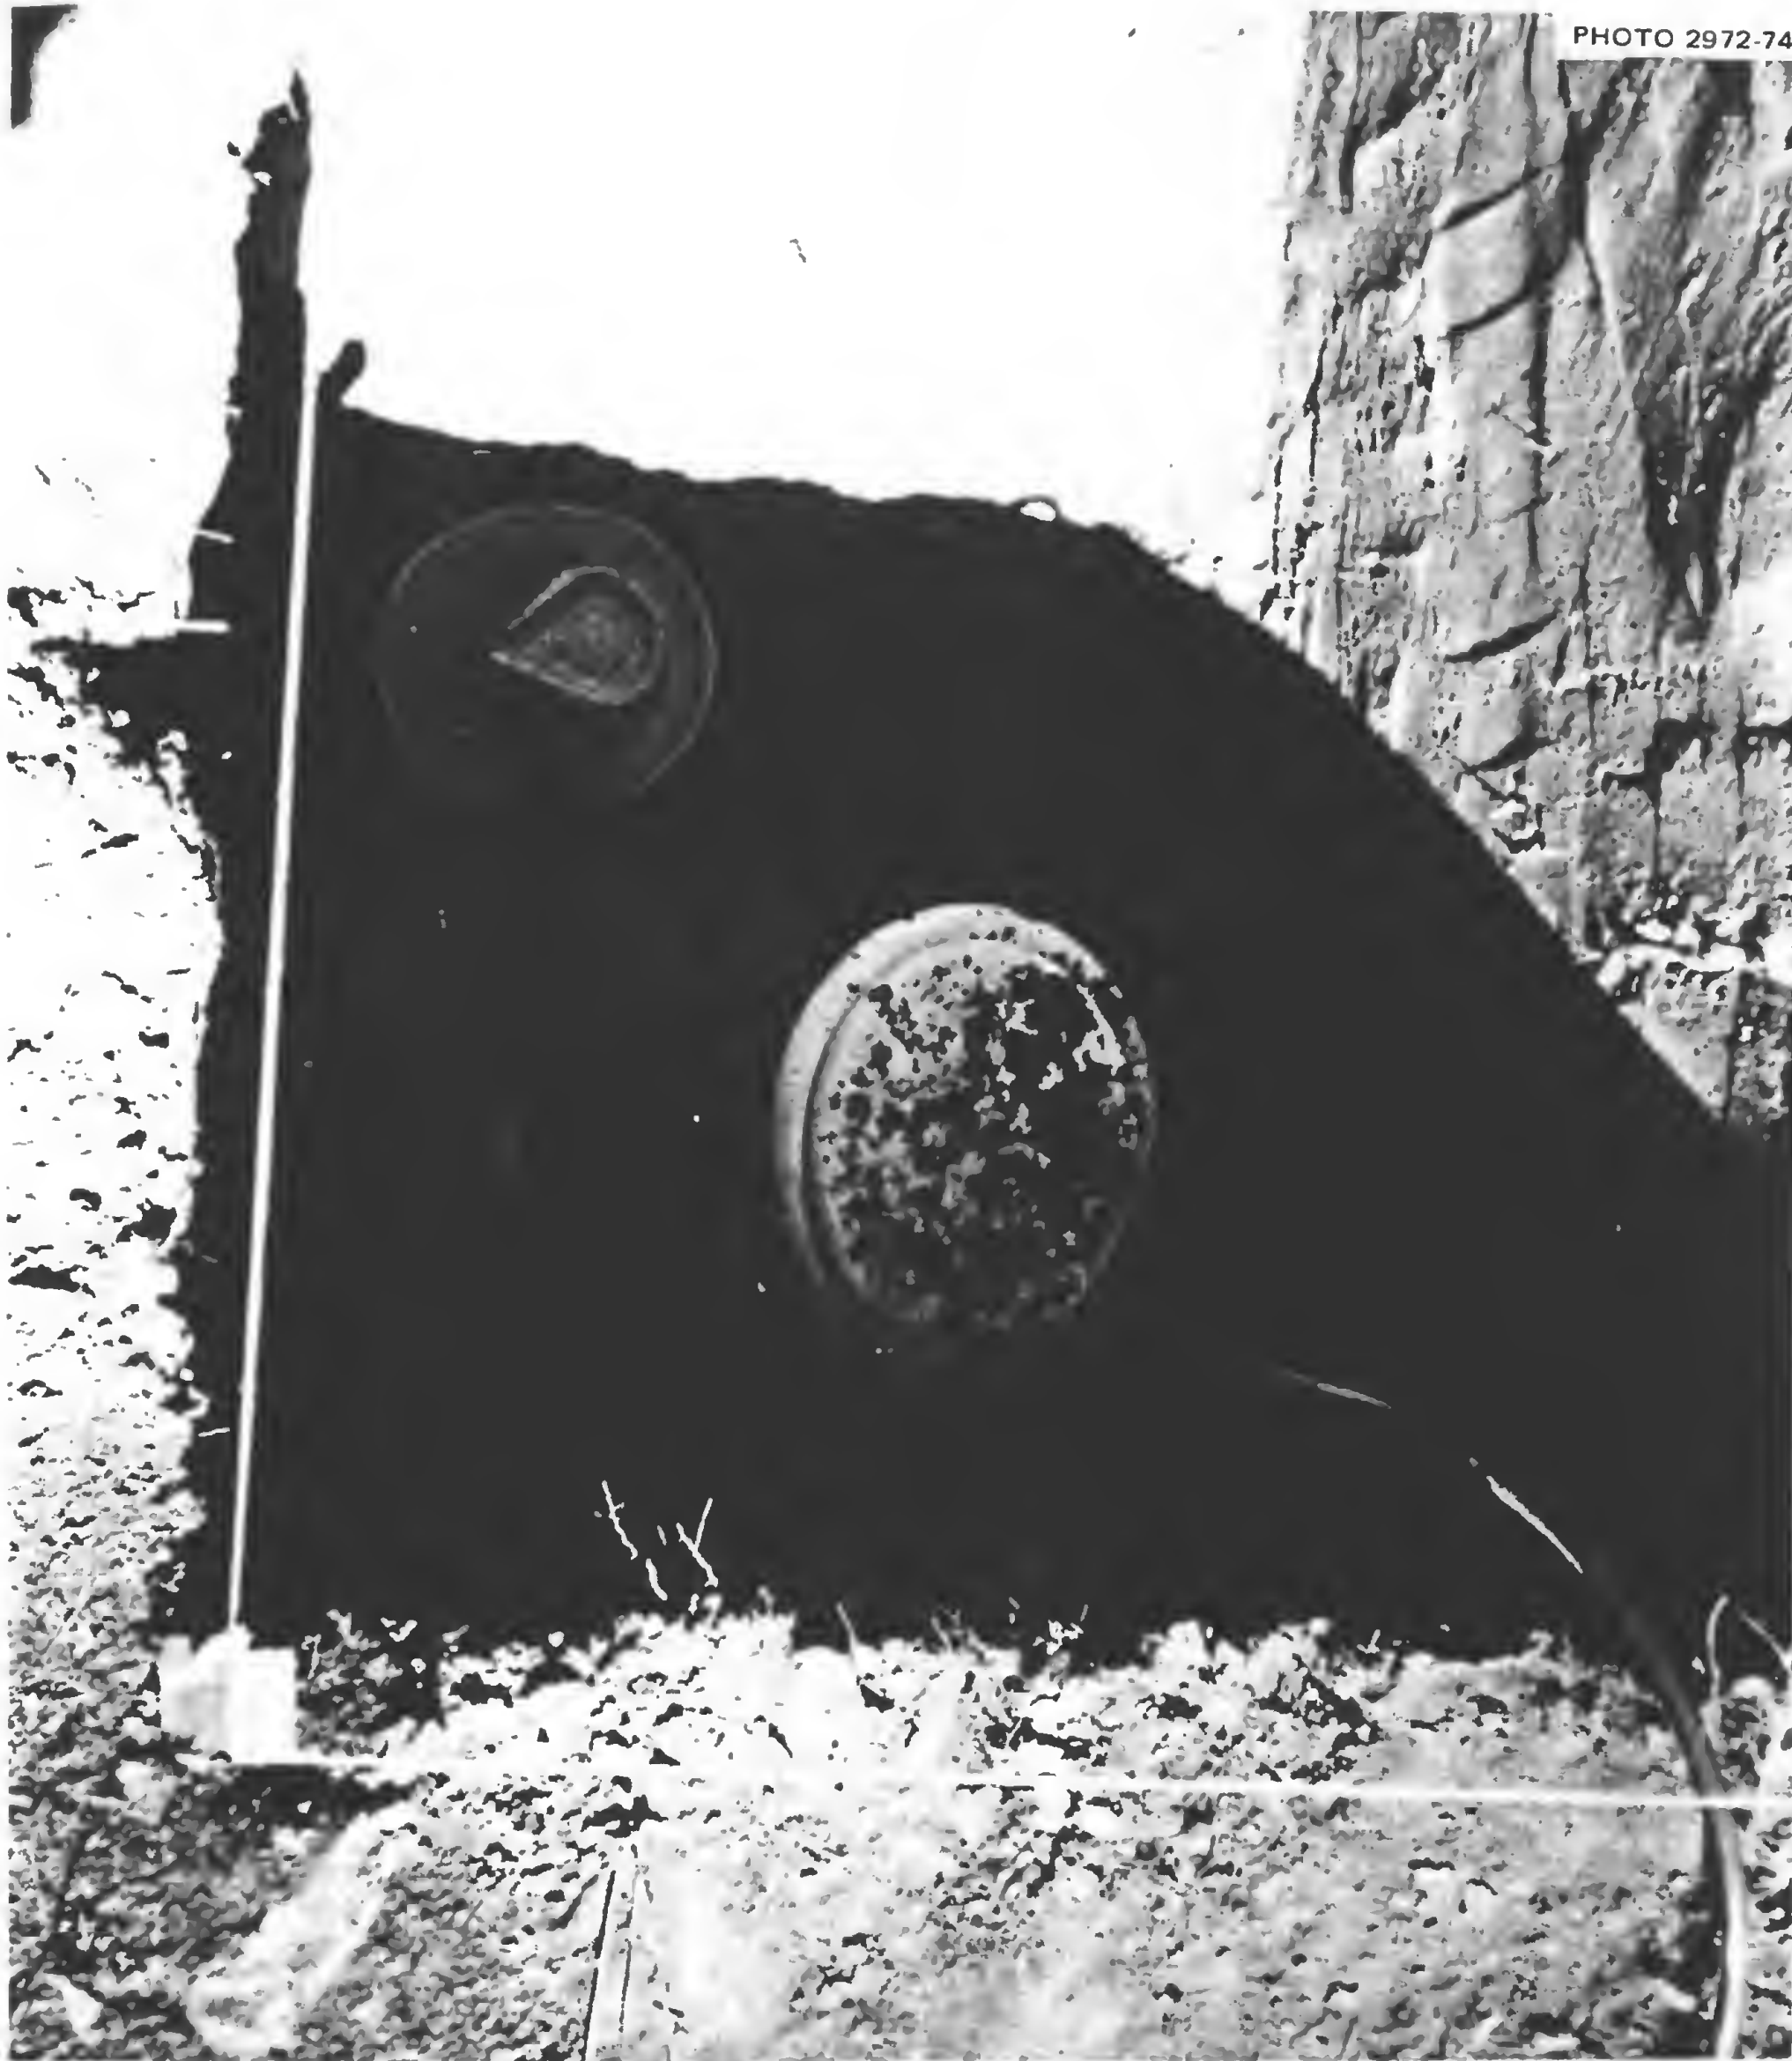
Fig. 4.29. View looking straight down on the installed toilet and its seat. The two assembled 5-gallon cans and the toilet bowl had been placed in a hole dug in the bottom of the shelter. A piece of  $\frac{1}{2}$ -in. plywood, in length equal to the 42-in. width of the shelter room and about 20 in. wide, served as the horizontal surface to which the toilet seat was attached. An appropriately sized, roughly elliptical hole had been cut in this plywood with a brace and bit and a cold chisel. The plywood base of the toilet was at floor level. Note the vent hose.

The 42-in.-wide threshold board is seen on the far edge of the stand-up hole. This and other threshold boards were installed on the edges of earth steps, and prevented the earth edges from being broken off, even after having been used for days.

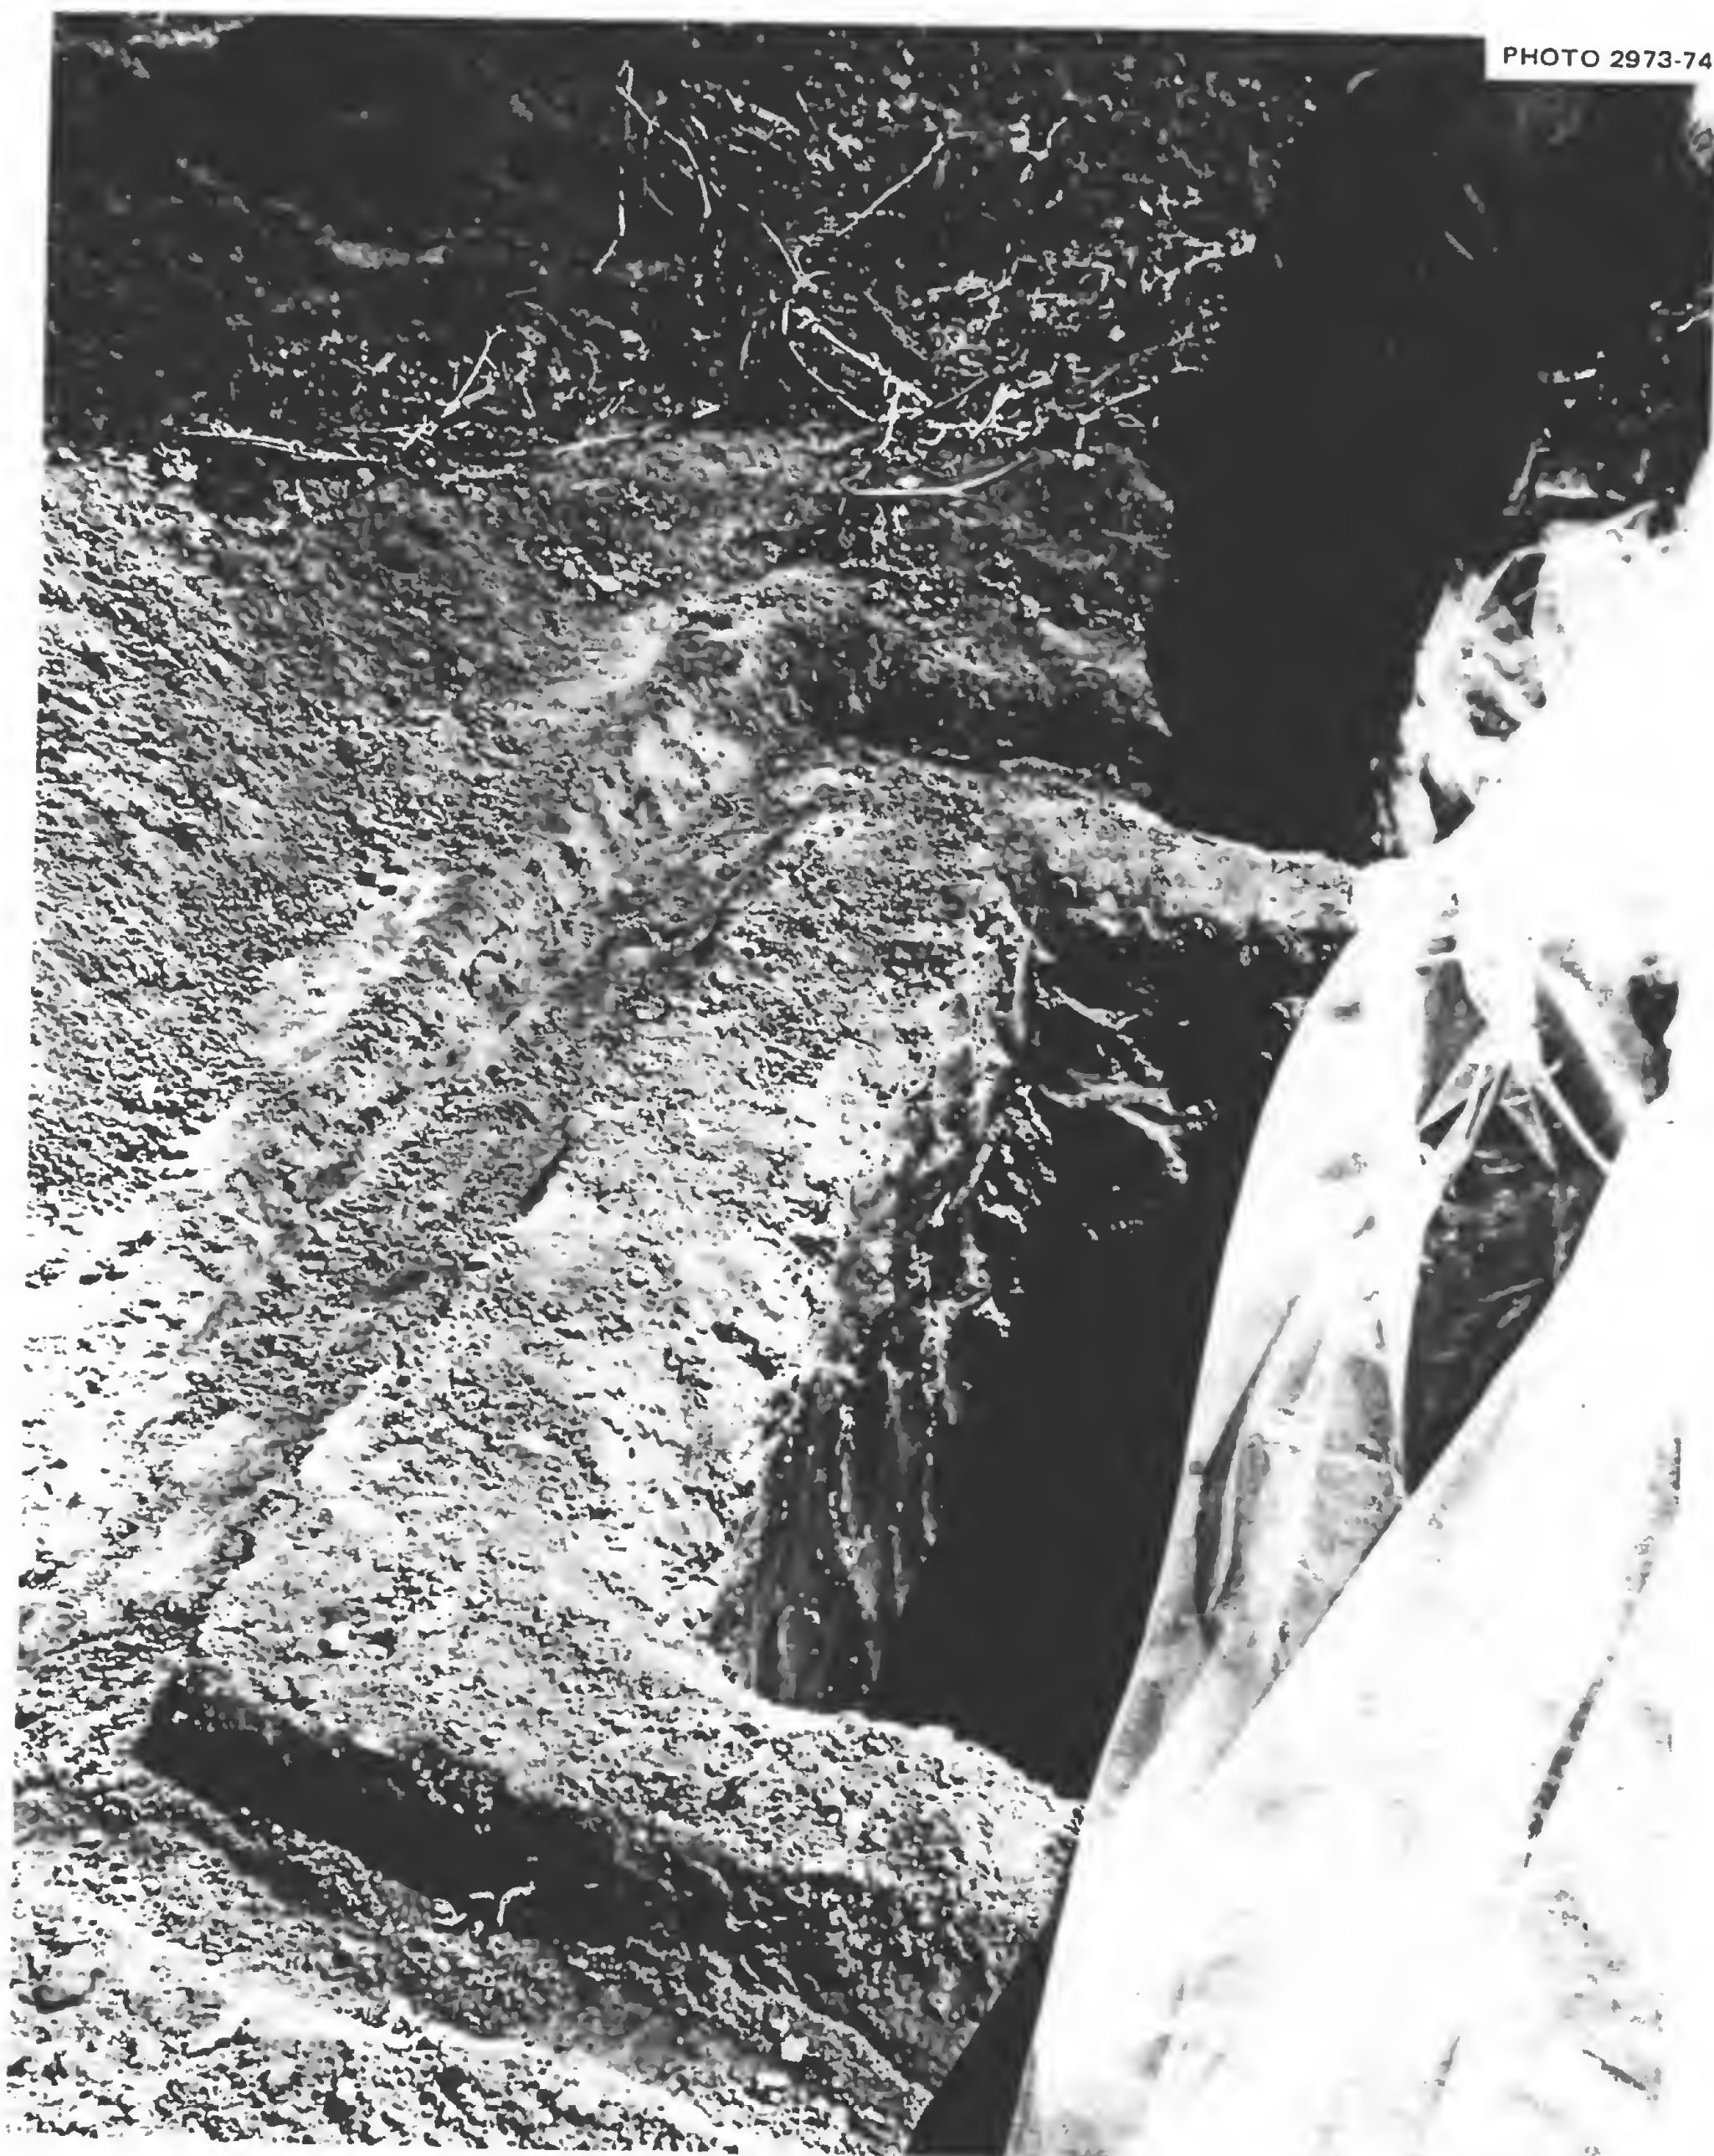
Fig. 4.34. Placing a sheet of 4-mil polyethylene in a 120-gallon water-storage pit. Unlike previous water-storage pits dug and tested by Kearny, this pit was not first lined with cloth or other material to keep sharp roots, etc., from puncturing the waterproofing plastic. All root ends were merely cut off with a knife. The edges of the plastic were folded into the small side trenches, and then held by packed earth. Six days after being filled, no leaks had developed.

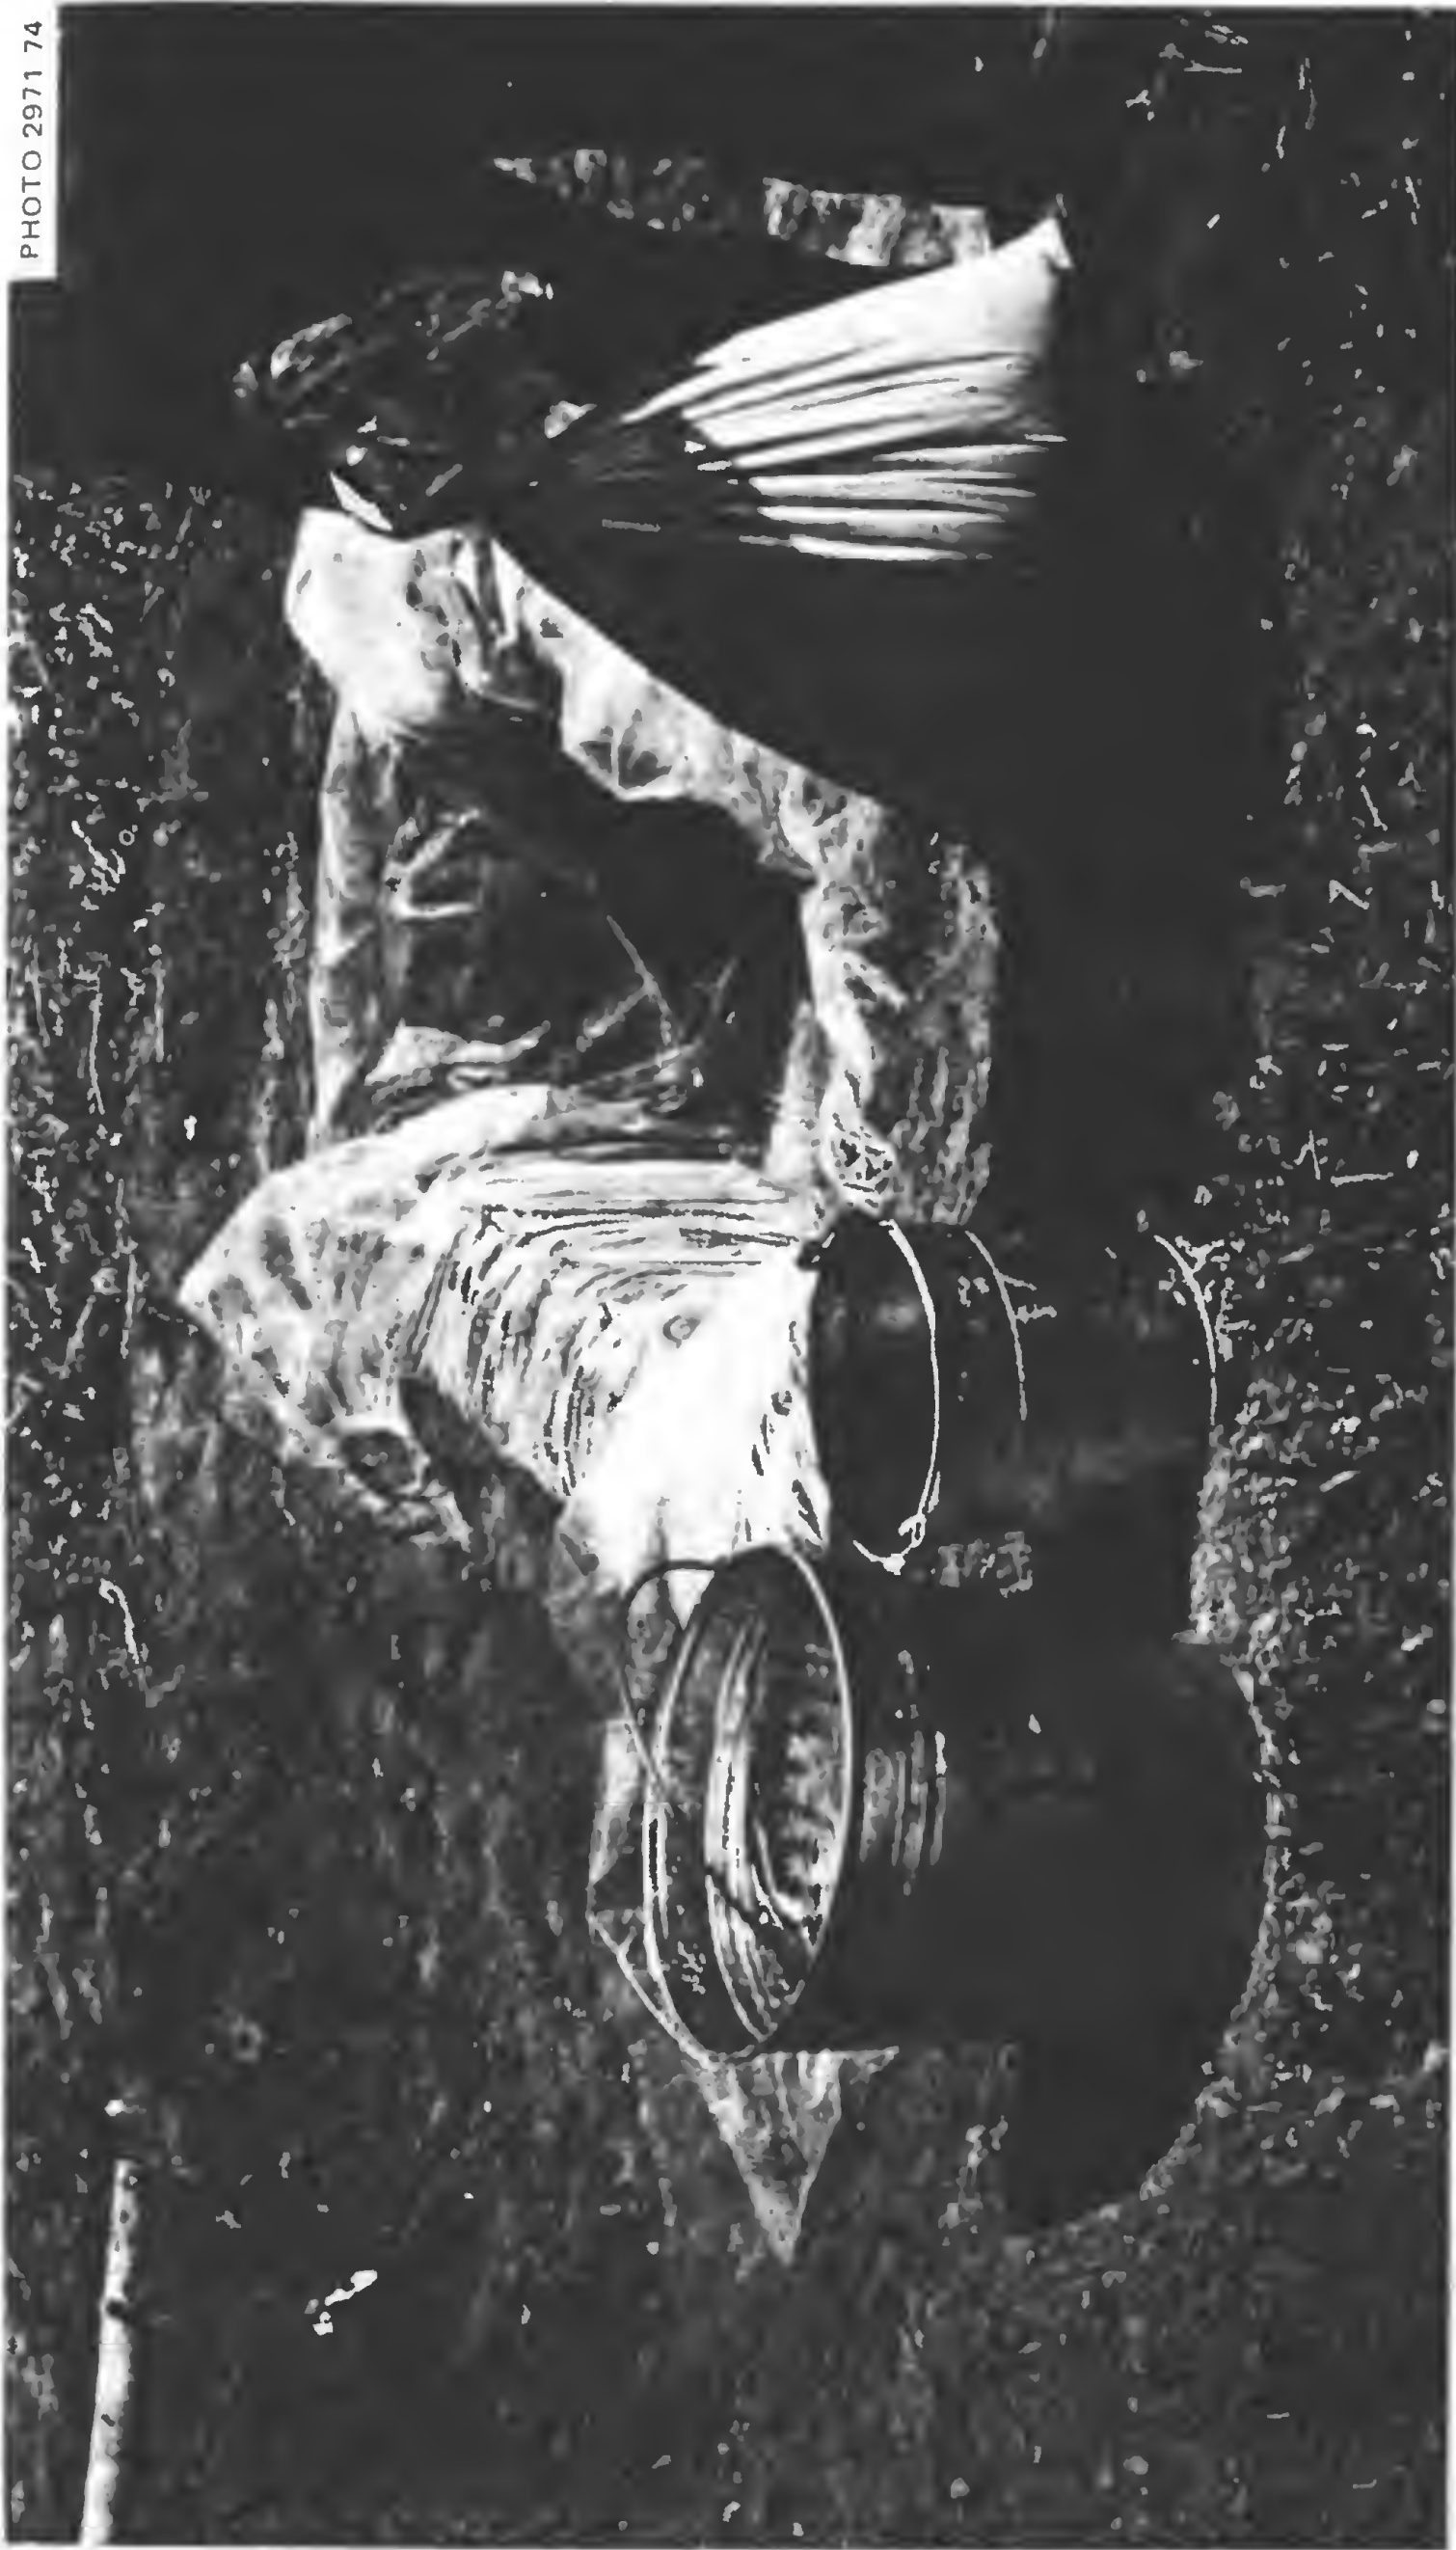
Fig. 4.35. The 120-gallon water storage pit of thin plastic being filled. This pit was later covered with boards, over which thin plastic was placed, and then earth was mounded over the boards, about 6 in. deep in the center. Next, a waterproof, outward-sloping "buried roof" of the plastic was laid on top of the mounded earth. Finally, about 4 in. of earth was mounded on top of the buried roof.
